BIOGENIC WEATHERING OF MARBLE MONUMENTS IN DIDIM, TURKEY AND IN TRAJAN'S COLUMN, ROME

Avinoam Danin

ABSTRACT

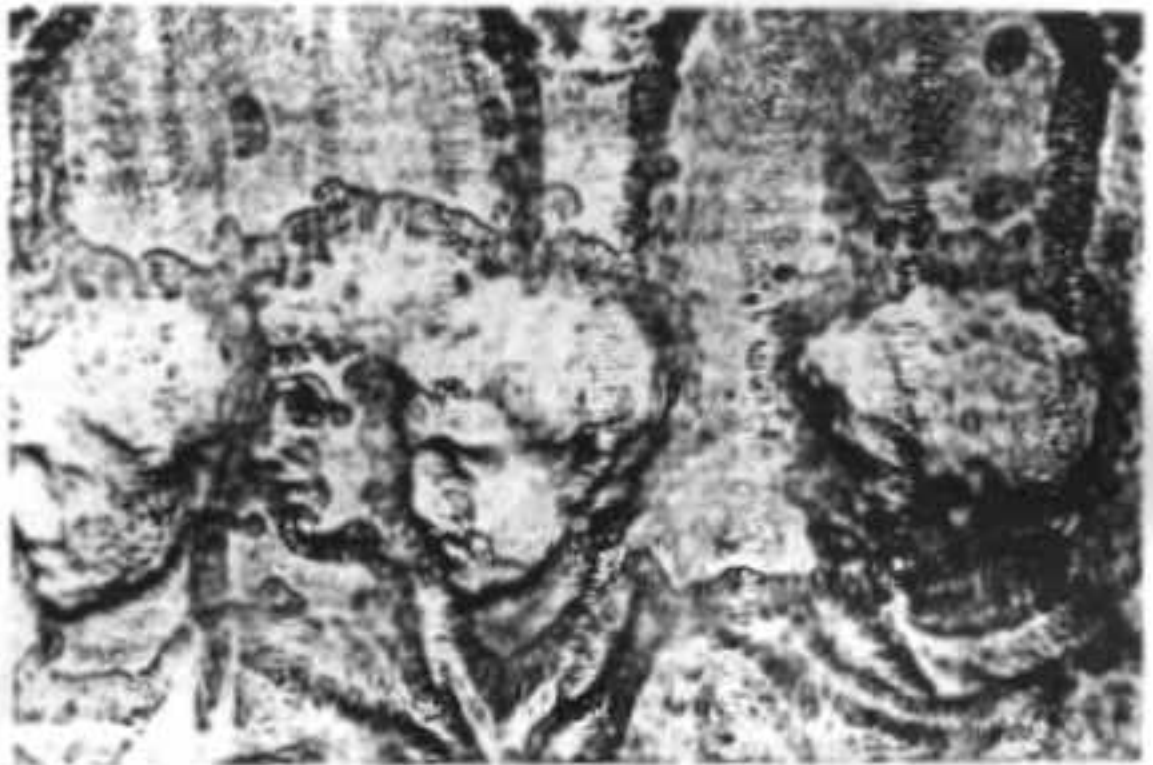
Fig. 1. Details of relief on Trajan's Column (in 1959) where the isolated pits are prominent on vertical parts and long depressions caused by joined pits or induced in a different way are common throughout.

In Trajan's column there are pits that resemble those populated by cyanobacteria in Didim and in other marble monuments in Rome (Fig. 1, top right and top left). The pits near figures or other reliefs on the monuments may be regarded as second kind of pits that join together to form long and irregular depressions. Similarities to this kind of weathering should be searched in marble monuments in Rome, where microorganisms are active at present. These pits and depressions have damaged much of the artistic relief on parts of Trajan's column. The most affected parts are those facing south and southeast. These are the directions of the most common incident rainfall in Rome which bring water at high energy to the vertical faces of the marble monument.

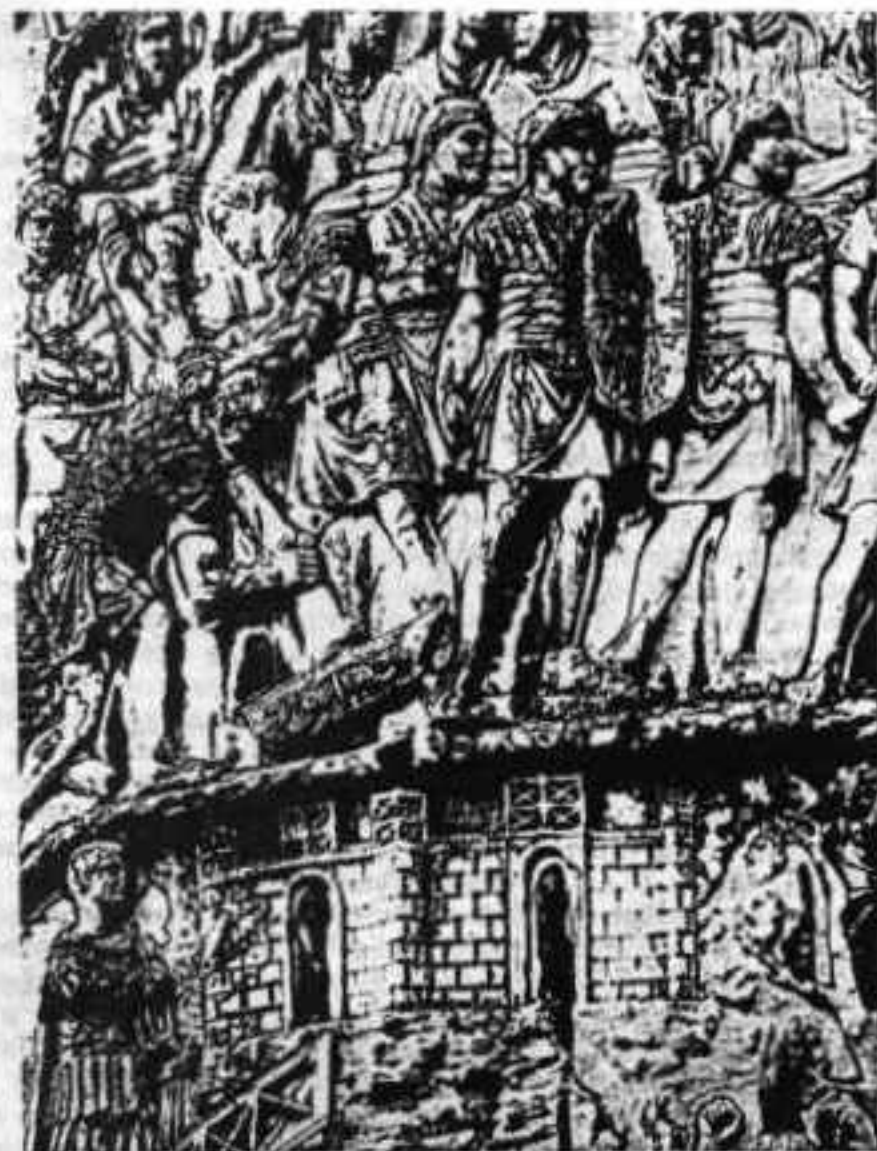
Fig. 3. Trajan's Column at the end of the 19th Century. Dark crust, possibly of cyanobacteria, is prominent in long and circular depressions. Such a crust does not exist there at present (cf. Fig. 1).

The edges of the pits on Trajan's column that were sharp and with a black microbial crust (Fig. 3) for a few hundred years until 1942 are blunt at present.
