BIOGENIC WEATHERING OF MARBLE MONUMENTS IN DIDIM, TURKEY  
AND IN TRAJAN'S COLUMN, ROME

Avinoam Danin

ABSTRACT

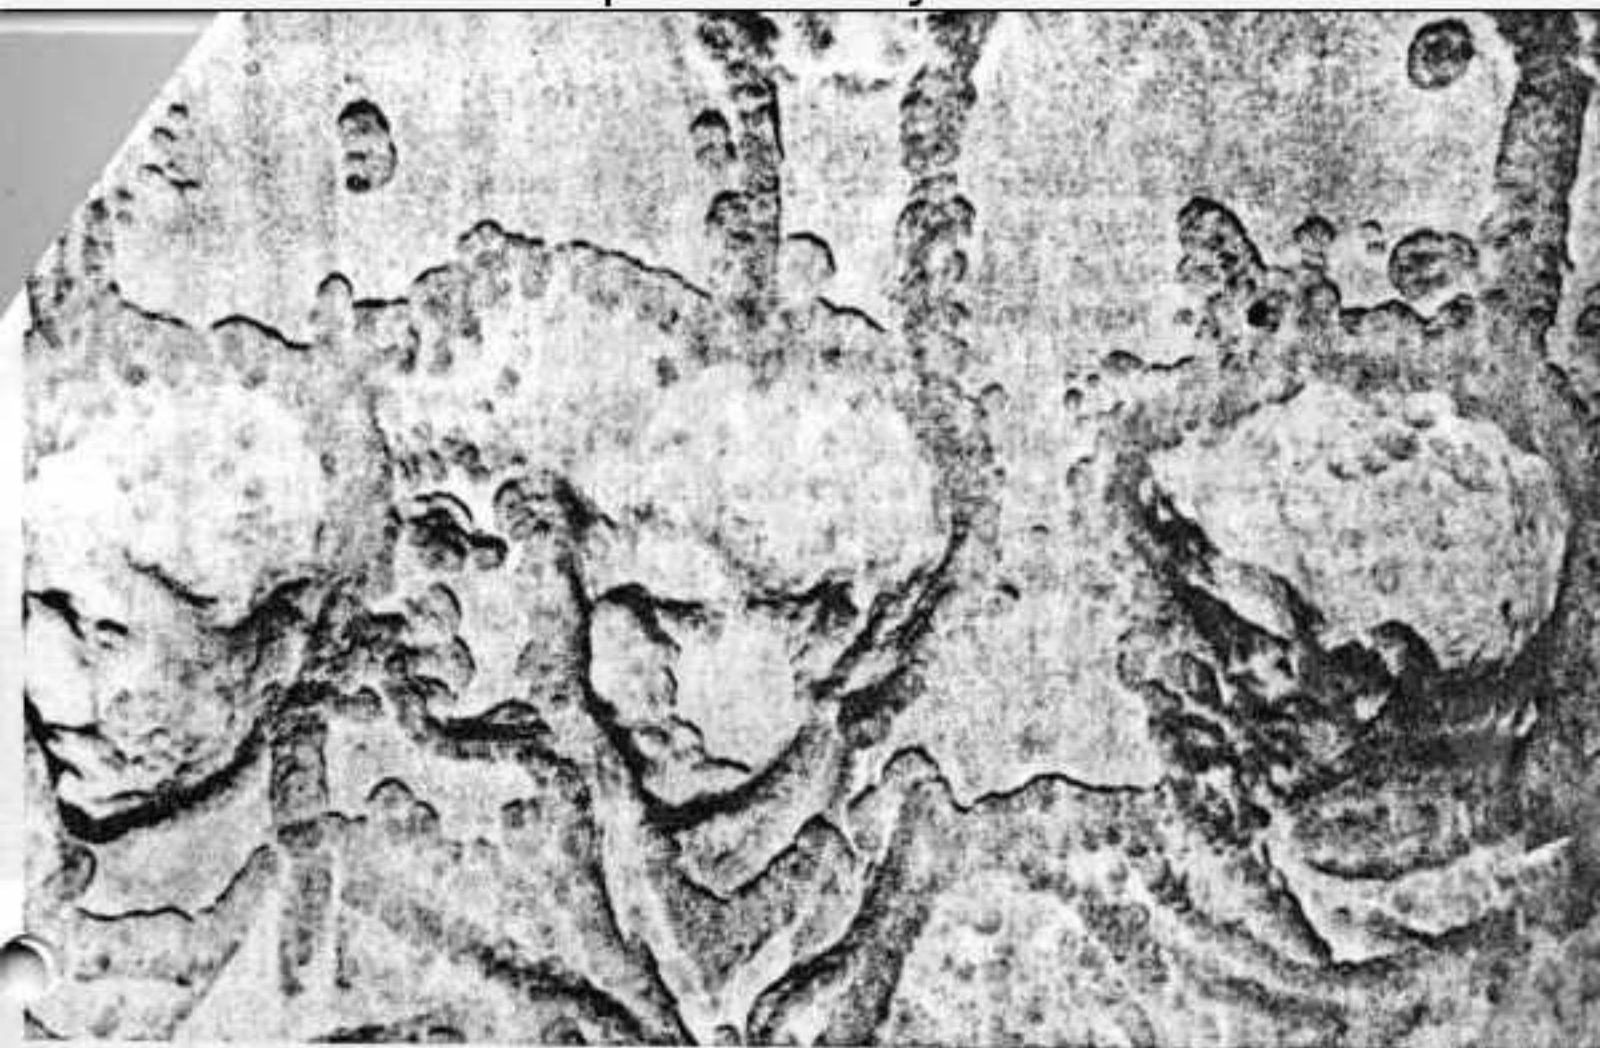
Fig. 1. Details of relief on Trajan's Column (in 1989) where the isolated pits are prominent on vertical parts and long depressions caused by joined pits or induced in a different way are common throughout.

In Trajan's column there are pits that resemble those populated by cyanobacteria in Didim and in other marble monuments in Rome (Fig. 1, top right and top left). The pits near figures or other reliefs on the monuments may be regarded as second kind of pits that join together to form long and irregular depressions. Similarities to this kind of weathering should be searched in marble monuments in Rome, where microorganisms are active at present. These pits and depressions have damaged much of the artistic relief on parts of Trajan's column. The most affected parts are those facing south and southeast. These are the directions of the most common incident rainfall in Rome which bring water at high energy to the vertical faces of the marble monument.

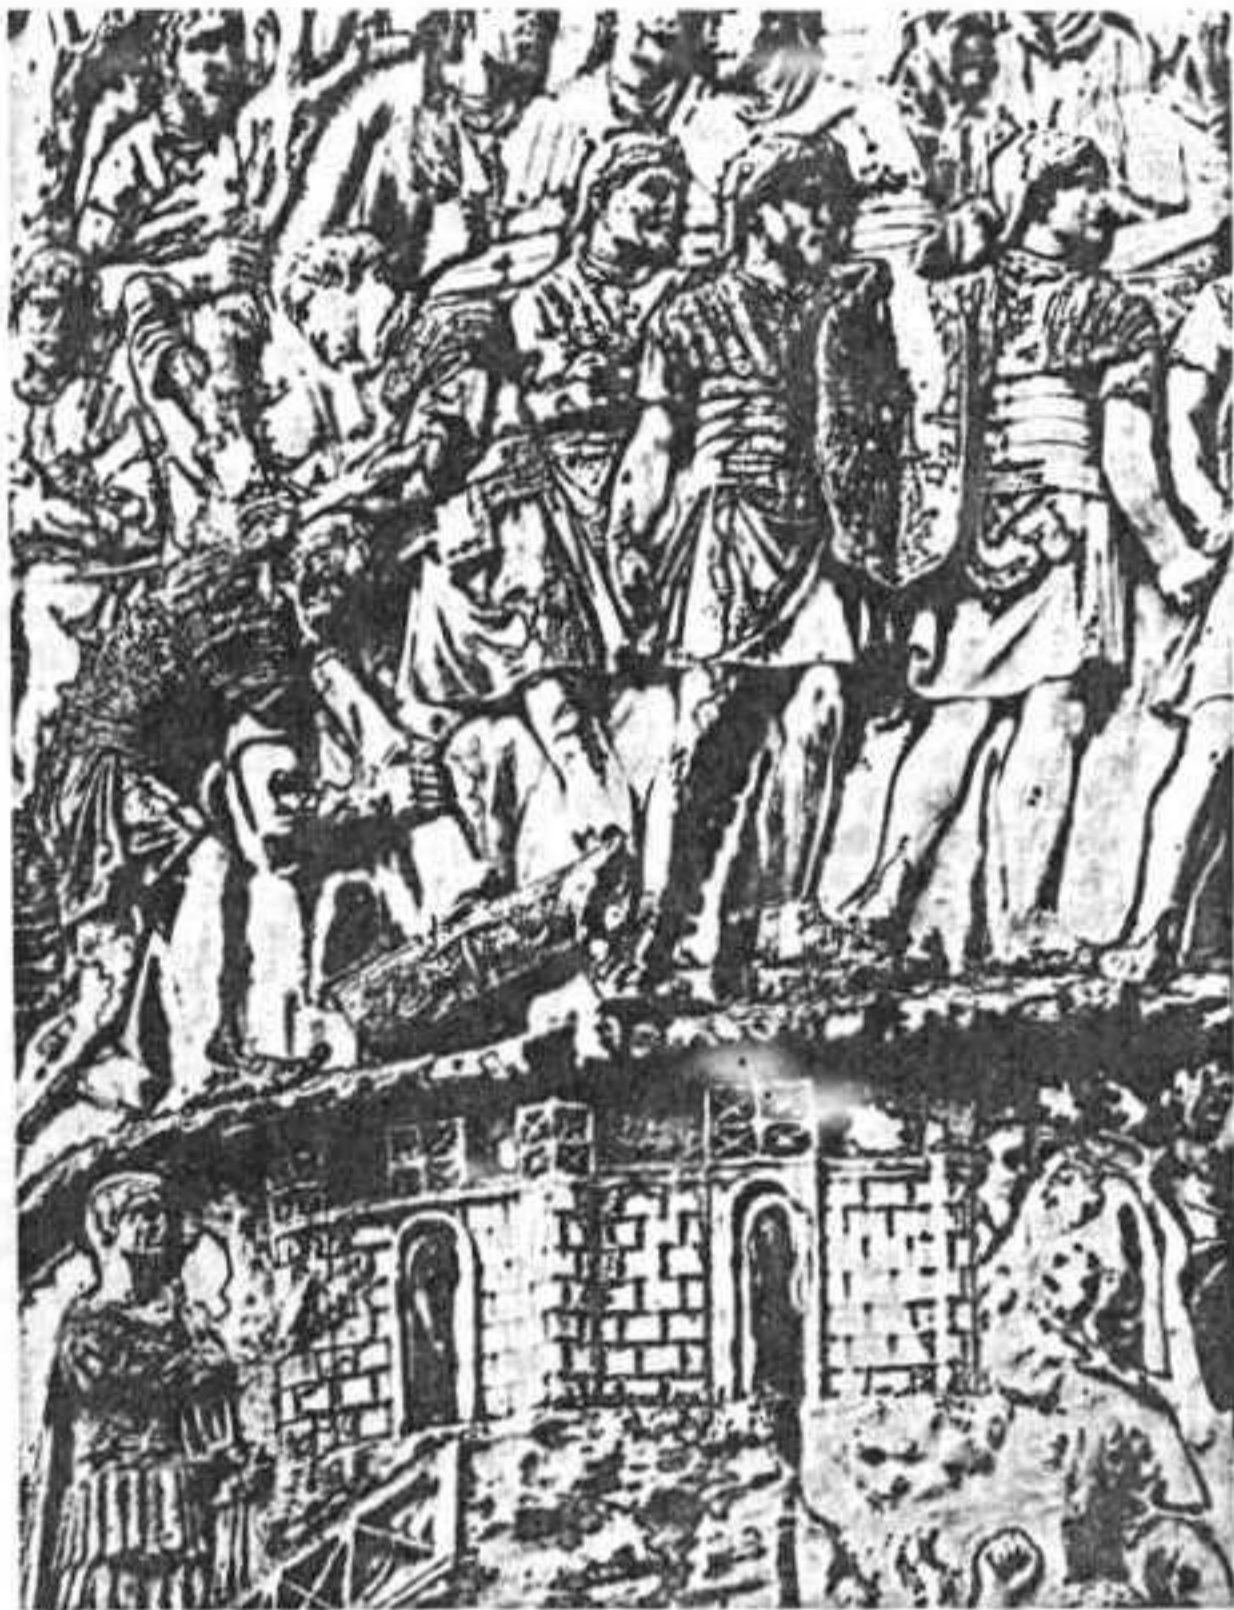
Fig. 3. Trajan's Column at the end of the 19th Century. Dark crust, possibly of cyanobacteria, is prominent in long and circular depressions. Such a crust does not exist there at present (cf. Fig. 1).

The edges of the pits on Trajan's column that were sharp and with a black microbial crust (Fig. 3) for a few hundred years until 1942 are blunt at present.

The second prominent process of weathering in Didim is pitting. As found by Caneva et al. (1992) in marble blocks in Trajan's and Roman Fori in Rome, there are several species of cyanobacteria that populate the pits. The pits are formed as a result of faster weathering near patches of these organisms. The microbial activity leads to a reduction in the coherence of marble crystals by increasing the acidity of water surrounding the microorganisms. The rate of splashing out of marble crystals from near the cyanobacteria is faster than that from marble with no such organisms. The result is that the rate of weathering near the round patch of cyanobacteria is higher than in the area not populated by them. The longer they live the deeper becomes the round hole, and a pit is formed (Danin and Caneva 1990). As long as the microorganisms which induced the formation of pits were alive on Trajan's Column there was a faster rate of weathering in the pits. The large difference between weathering rates in and out of the pits was expressed in the sharp edges of the pits. As a result of the protection measures against the 2nd World War hazards, the pits' microorganisms disappeared. The general weathering processes that influenced the entire surface indifferently led to the weathering of the sharp edges, thus making them blunt.
